**Flood Control Project Maintenance
Levee Inspections**

2018 Channel Summary Report

Fairfield Suisun Sewer District

Flood Control Project Maintenance**Unit Cover Sheet****2018 Channel Inspection Results****Fairfield Suisun Sewer District**

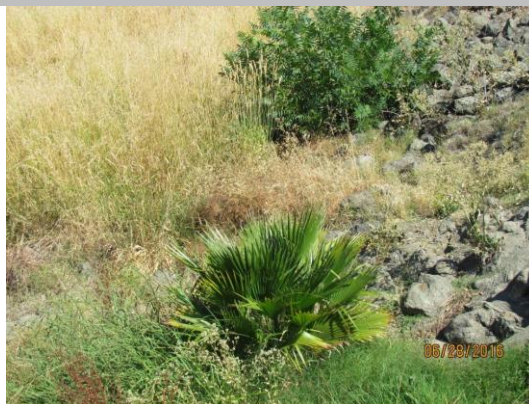
Photo 4 of 5 : CH_2018_NA0035_15_1_20180529_00003.jpg

Suggest removal of volunteer palm tree. Summer 2016.

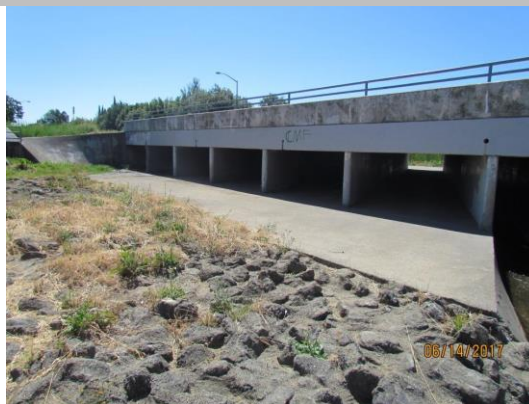
Photo 1 of 1 : CH_2018_NA0035_15_92_20180529_00068.jpg

Inspector Comments: Concrete surface appears to be in good condition with no visible deficiencies.

View of concrete surface, looking downstream at Cement Hill Road bridge. Summer 2017.

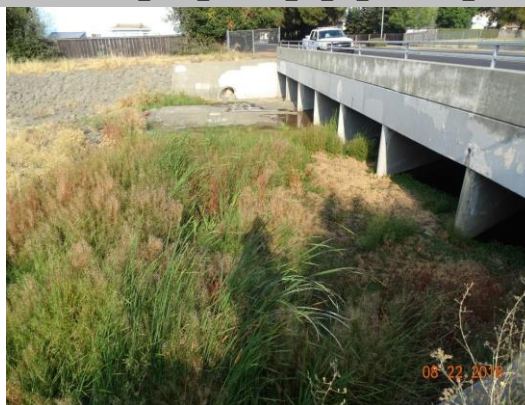
Photo 1 of 2 : CH_2018_NA0035_15_93_20180823_00088.jpg

Rating **	A	Issue No.	93	GPS Lat/Long
Issue Type +	Ma	Location *		38.279793 °
Category	Rivers, Channels & Designated Flood			-122.018267 °
Item	Concrete Surfaces			
DWR ID	DWR_NA0035_15_c_2017_93			
Action/Comments				
Inspector Comments: Concrete surface appears to be in good condition with no visible deficiencies. Recommend removing vegetation.

View of the concrete surface looking at the right bank. Summer 2018.

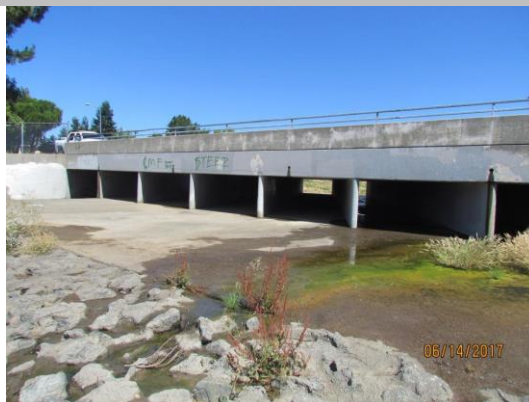
Photo 2 of 2 : CH_2018_NA0035_15_93_20180529_00069.jpg

Inspector Comments: Concrete surface appears to be in good condition with no visible deficiencies. Recommend removing vegetation.

View of concrete surface looking upstream towards Cement Hill bridge. Summer 2017.

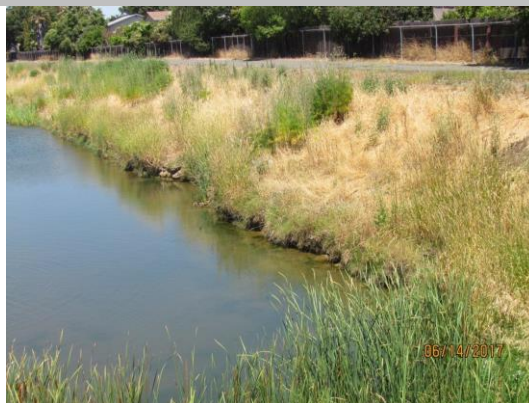
Photo 1 of 1 : CH_2018_NA0035_15_43_20180529_00035.jpg

Rating **	A	Issue No.	43	GPS Lat/Long
Issue Type +	Ma	Location *		38.259230 °
Category	Rivers, Channels & Designated Flood			-122.017714 °
Item	Erosion / Bank Caving			
DWR ID	DWR_NA0035_15_c_2012_43			
Action/Comments				
Inspector Comments: Minimal erosion along channel banks that does not appear to be an issue at this time. Recommend monitoring.

View of minor erosion on left bank looking upstream. Summer 2017.

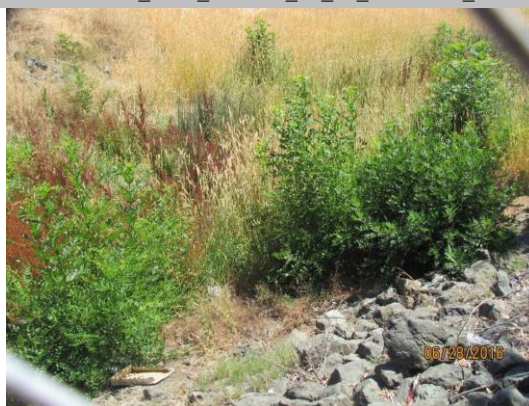
Photo 4 of 4 : CH_2018_NA0035_15_66_20180529_00051.jpg

Suggest removal of woody vegetation near the right bank revetment. Summer 2016.

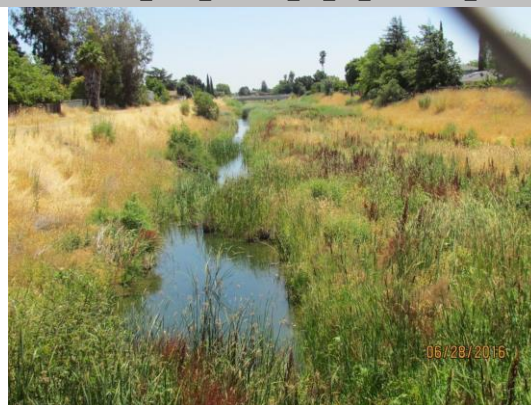
Photo 3 of 4 : CH_2018_NA0035_15_76_20180529_00059.jpg

View of the channel looking downstream from Blossom Rd. Woody vegetation has been removed. Summer 2016.

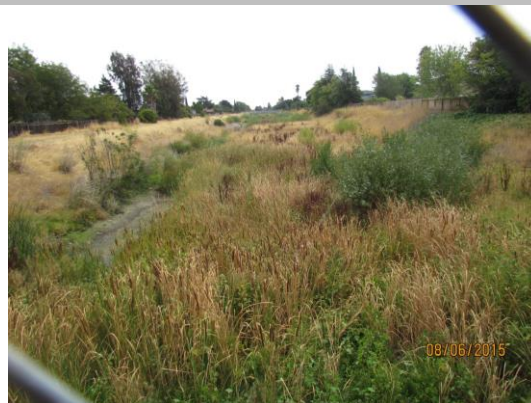
Photo 4 of 4 : CH_2018_NA0035_15_76_20180529_00060.jpg

Looking downstream from Blossom Rd. Suggest removal of woody vegetation. Summer 2015.

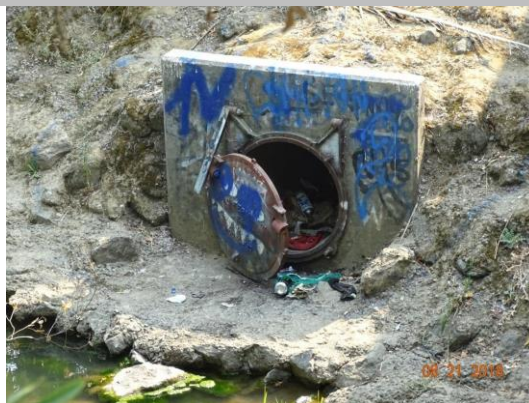
Photo 1 of 2 : CH_2018_NA0035_17_24_20180823_00074.jpg

Inspector Comments: Flap gate on nearby drainage pipe is broken and should be repaired, but does not have an affect on the capacity of the channel.

View of the flap gate located on the upstream side of Rockville Rd. Summer 2018.

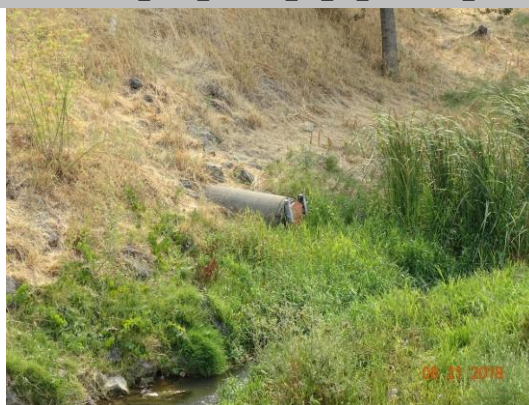
Photo 1 of 3 : CH_2018_NA0035_17_82_20180823_00065.jpg

Inspector Comments: Gates open and close easily with minimal leakage. Gates show no corrosion damage and have been maintained.

View of the gate on the downstream side of the channel from Auto Mall Pkwy. Summer 2018.

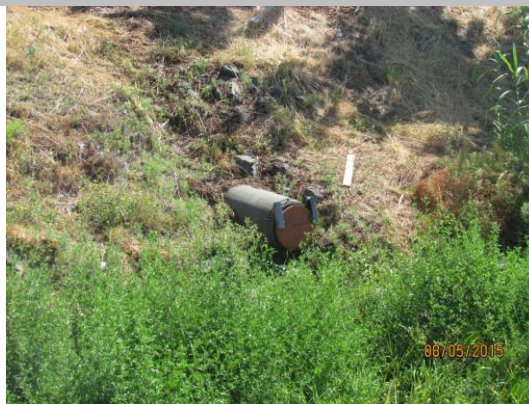
Photo 3 of 3 : CH_2018_NA0035_17_82_20180529_00057.jpg

Inspector Comments: Gates open and close easily with minimal leakage. Gates show no corrosion damage and have been maintained.

View of the gate looking downstream from Auto Mall Pkwy. Summer 2015.
